### PRODUCT MODELS

- C-EP Cover
- Legend Cover

#### PURPOSE OF THE PROCEDURE

This procedure should be performed when the sleeves seem to interfere with the operation of the cover and/or when the sleeves need to be aligned with each other on a C-EP or Legend swim spa cover.

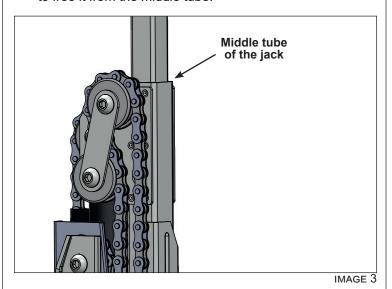
- Slide the middle sleeve down into the outer sleeve.
- If you noted earlier that the inner sleeve got caught on the middle tube of the jack (see image 3) (this may be due to the over-extension of the posts and/or misalignment of the sleeves), proceed with the following: After sliding the middle sleeve down into the outer sleeve, lift the cover to its maximum height, ensure the middle chain is still attached to the jack body (use a tie wrap to secure the chain on the jack frame). Then, gently hit the inner sleeve to free it from the middle tube.

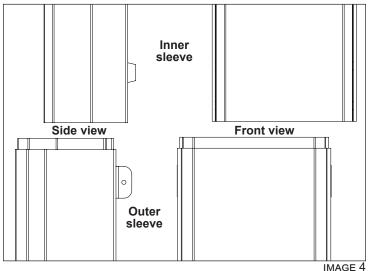
Image 4: Outer sleeve misaligned

- 1) To fix the misalignment of the outer sleeve (image 4), align the top of the outer sleeve with the base of the inner sleeve (image 5), then, without moving the top of the outer sleeve, repostion the tub mount lower bracket to level the base of the outer sleeve using a 36" level.
- 2) Use the key switch to raise and lower the cover to ensure the proper function of the sleeves. There should be no "sticking" of the sleeves, no abnormal sounds (metal grinding or knocking), and the cover should be evenly seated all around the spa perimeter.

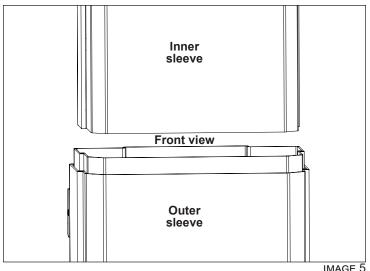
Image 5: Outer sleeve aligned
