PRODUCT MODELS (North America & Europe)

- Evolution cover
- Oasis Cover

PURPOSE OF THE REPAIR PROCEDURE

This repair procedure should be performed if the capacitor needs to be replaced on the Evolution or Oasis spa cover.

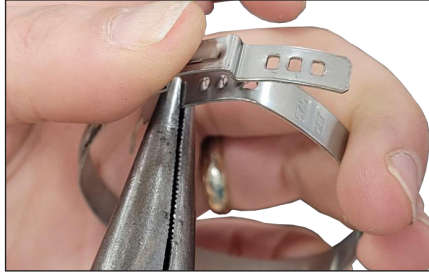
IMAGE 4

Using long nose pliers, unhook the tab.

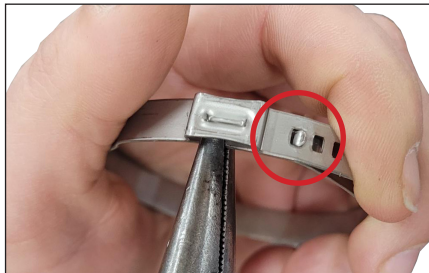
IMAGE 5

Then, adjust the pinch clamp to the closest tab.

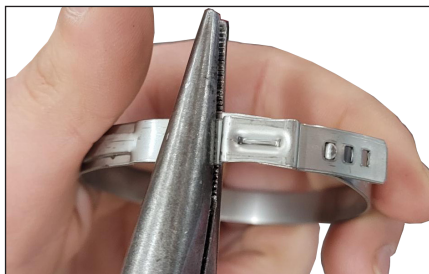
IMAGE 6

Secure the position by pinching the pinch clamp with the pliers as illustrated at right.

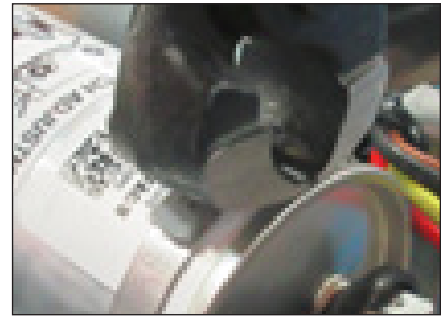
IMAGE 9

- 5) Using ear clamp pliers, grab the indents of both sides of the ear, then squeeze the tool. Pinch as tight as possible without damaging the clamp. Repeat for the other pinch clamp.

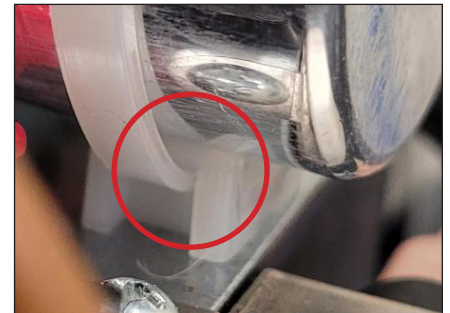
IMAGE 14

- 2) Place the new capacitor on the supports, ensuring its position matches the final assembly illustrated at right.

- 3) Slide a cable tie at each end of the capacitor, making sure they go through the supports.

- 4) Tighten the cable tie as tight as possible. Repeat for the other cable tie. Cut off the excess.
