PRODUCT MODELS

PURPOSE OF THE REPAIR PROCEDURE

This repair procedure should be performed if the chain needs to be replaced on the Evolution or Oasis spa cover.

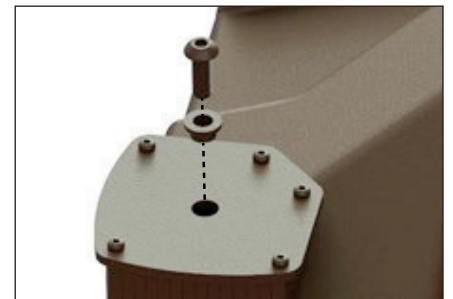
IMAGE 3

- 4) Remove the 3/8-24 x 1" Allen bolt with a 7/32" Allen key from the defective post only. **Do not discard!**

- 12) Reinstall the 3/8-24 x 1" Allen bolt with the narrow part of the bushing facing downwards using a 7/32" Allen key on the post (see image 3).
- 13) Using a Robertson screwdriver, reinstall the three top plates with five no. 8 x 3/4" screws each (see image 5).
- 14) Ensure the cover is still centered. Use a measuring tape on all four sides. Also, verify whether all the posts are vertically leveled with a 36" level.

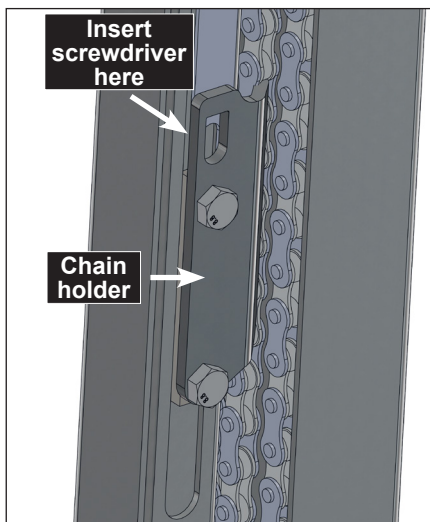
IMAGE 7

- 9) Place locking pliers on the inner tube of the defective jack only, and turn the key switch to lower the jack about 1". This will release the pressure on the chain.

- 10) Cut the shrink tube at both ends of the defective chain.

Unhook the defective chain from the front of the jack (see image 8) and from the chain holder (image 7). **If need be**, use a flat blade screwdriver to slightly bend the top of the chain holder outwards, to help unhook the chain.

- 1) Insert one of the shrink tubes on the new chain.
2) Run the new chain through the pulley and insert it in the chain holder (see image 7). Then, keeping the chain vertical, lower the shrink tube as close as possible to the end of the hook. Use a heat gun to apply heat to the tube. If need be, use a hammer and a round tip punch to carefully tap the top of the chain holder back in place.

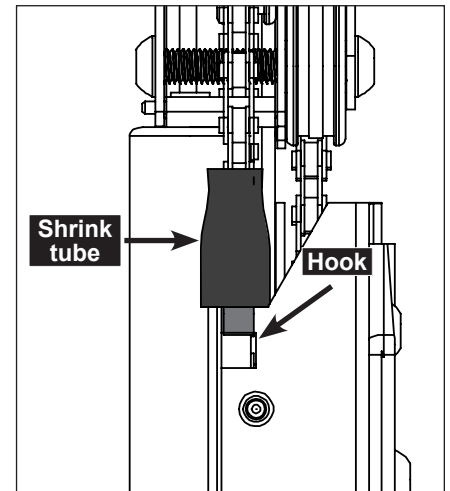
IMAGE 8

- 3) Insert the second shrink tube on the chain. Then, insert the hook in the front of the jack and pull it up so it's properly seated. Lower the shrink tube as close as possible to the end of the hook. Use a heat gun to apply heat to the tube.

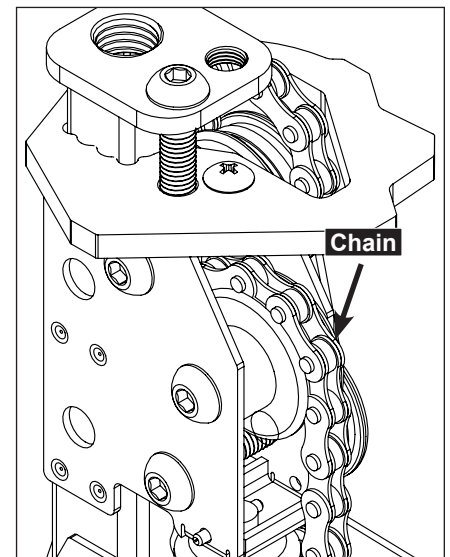
IMAGE 9

- 4) Using the key switch, elevate the cover to apply full pressure to the chain.

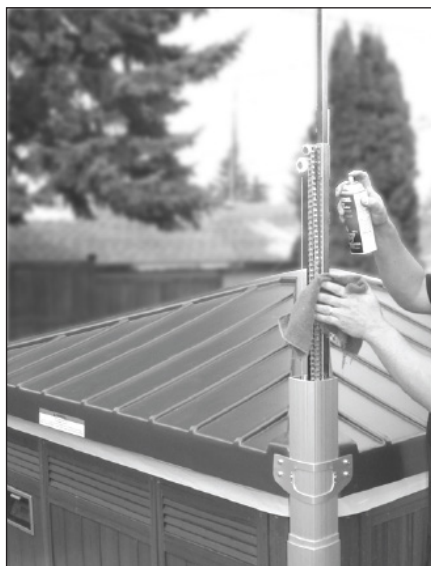
IMAGE 10

Since the four jacks are currently accessible, it is strongly suggested to grease all of them to ensure peak performance.

- 6) Ensure the cover is lowered completely and the jacks are extended to their full height.

- 7) For each jack, using white grease spray, lubricate all the mechanical components that are visible, especially the vertical tubes.
