PRODUCT MODELS

- Evolution Cover
- Oasis Cover

PURPOSE OF THE ADJUSTMENT PROCEDURE

This procedure should be performed when a unit does not move or slightly moves or is stuck unlevelled. It is not applicable for a unit with visually noticeable mechanical malfunctions.

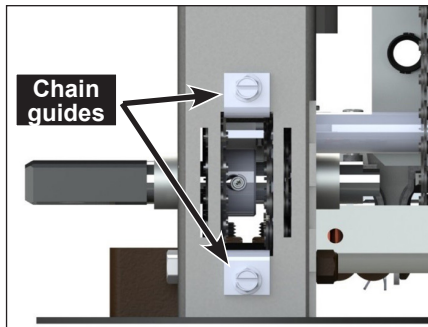
IMAGE 1

- 1) Check that the chain guides are correctly positioned (therefore **almost** touching the chain) in order to prevent the chain from jumping.

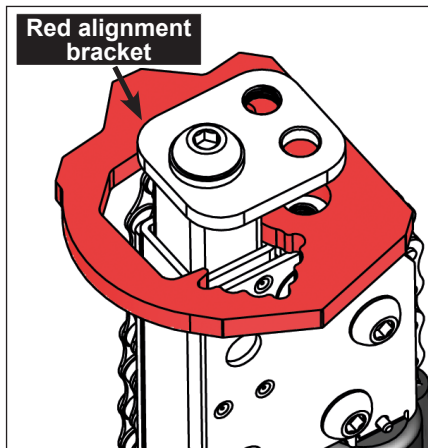
IMAGE 2

- 2) If the cover is from **April 2019 and up** (or retrofitted) make sure that the red alignment bracket is in place (G3 jacks only).

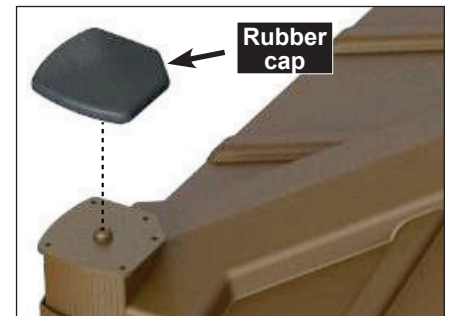
IMAGE 3

- 1) Remove the rubber cap from each post.

- 1) Remove the rubber cap from each post (see image 3).
- 2) Remove the four M6 x 20 mm bolts and 5/16" painted metal washers from each post to have the cover sit flat on the spa. Leave the bracket attached to the sleeve (see image 4).
- 3) Remove the 3/8-24 x 1" Allen bolt with a 7/32" Allen key from each post (see image 5).
- 4) Loosen the Phillips M6 x 20 mm screw at the bottom of each post. Do not remove the screw (see image 6).
- 5) Slide the sleeves upward to expose the jack. Set them aside in a safe location.
- 6) If the jack is from **March 2019 or earlier (G2)**: For the posts on the lower side, put the jack lock back in its original place and install the M4 x 8 mm screw to secure it. Turn the shaft with the key to align it with the bracket if need be (see image 7).

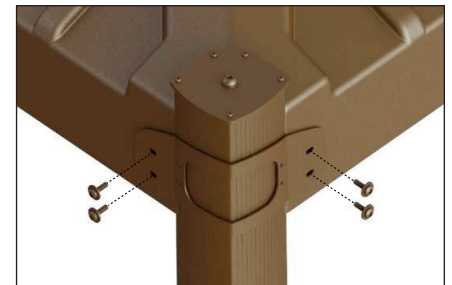
IMAGE 4

- 2) Remove the four M6 x 20 mm bolts and 5/16" painted metal washers from each post to have the cover sit flat on the spa. **Do not discard!** Leave the bracket attached to the sleeve.

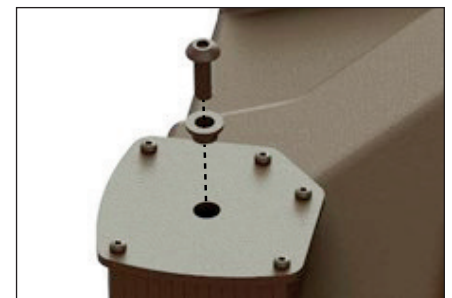
IMAGE 5

- 3) Remove the 3/8-24 x 1" Allen bolt with a 7/32" Allen key from each post. **Do not discard!**

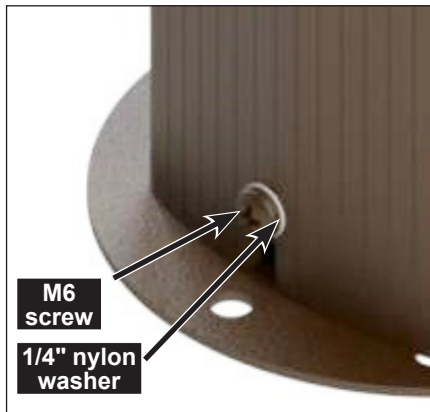
IMAGE 6

- 4) Loosen the Phillips M6 x 20 mm screw at the bottom of each post. **Do not remove the screw.**

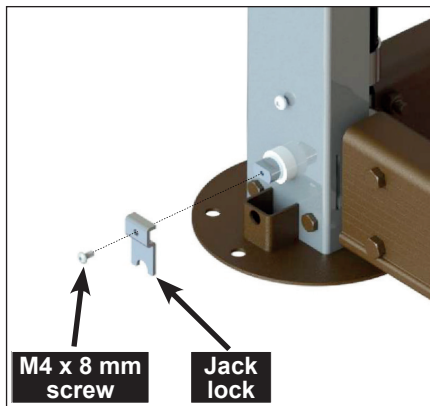
IMAGE 7

- 6) If the jack is from **March 2019 or earlier (G2)**: For both motor posts, put the jack lock back in its original place and install the M4 x 8 mm screw to secure it. Turn the shaft with the key to align it with the bracket if need be.

- 14) If the jack is from **March 2019 or earlier (G2)**, unscrew the Phillips M4 x 8 mm screw to remove the jack lock at the bottom of the posts on the higher side. **Keep the locks and the hardware for future use** (see image 7).

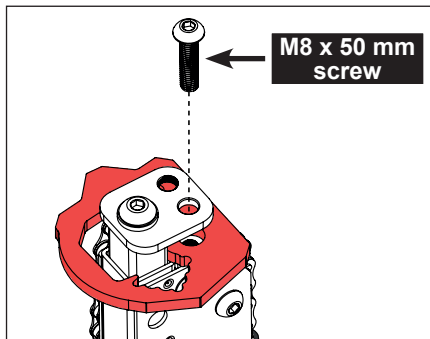
IMAGE 8

- 7) If the jack is from **April 2019 and up (G3)**: For both motor posts, use the M8 x 50 mm screw at the top of the jack to lock it.

If the jack is from **April 2019 and up (G3)**, remove the M8 x 50 mm screw at the top to unlock the posts on the higher side (see image 8).

If the jack is from **April 2019 and up (G3)**: For the posts on the lower side, use the M8 x 50 mm screw at the top of the jack to lock it (see image 8). Install a ratchet strap on the higher side with some tension in it.

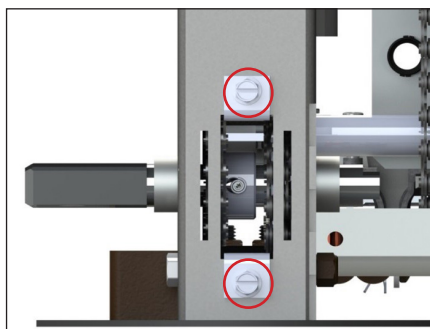
IMAGE 9

- 8) Remove the screws holding the chain guides in place. Then, remove both chain guides from the jacks on the higher side.

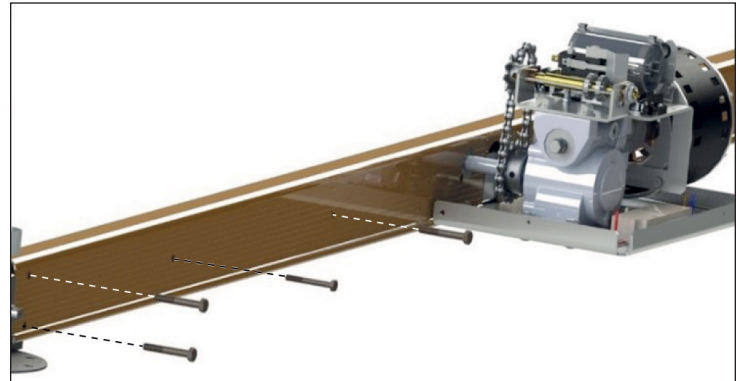
IMAGE 10

- 9) Remove all the hexagonal screws on the motor side U-frame, including both screws going into the operator. Gently lift the U-frame and set it aside (see image 10).

- 7) Remove the screws holding the chain guide in place. Then, remove both chain guides from the jacks on the lower side.
- 8) Remove all the hexagonal screws on the motor side U-frame, including both screws going into the operator. Gently lift the U-frame and set it aside (see image 10).
- 9) Remove the chain tensioners from the chain (see image 11).
- 10) Remove the anchoring from the jack base plate and pull the jacks closer to one another so the chain loosens (see image 12).
- 11) Remove the chain adapter link with a flat blade screwdriver from the motor chain on the lower side (see image 13).

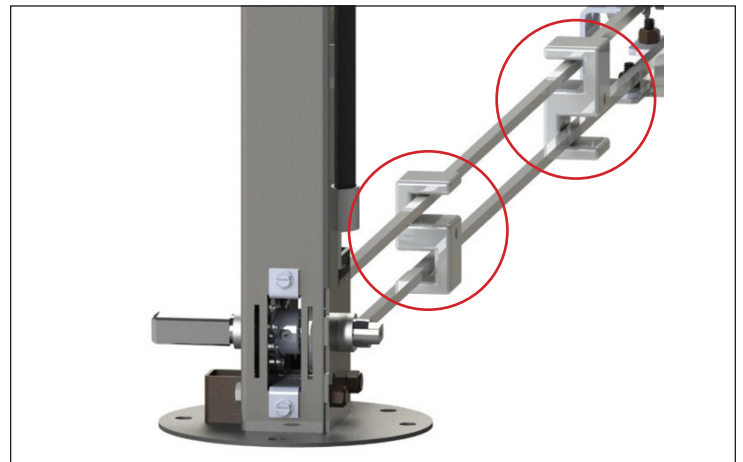
IMAGE 11

- 11) Remove the chain tensioners from the chain (see image 11).

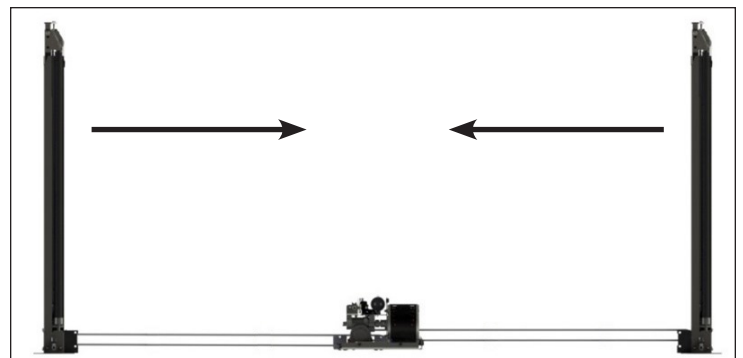
IMAGE 12

- 12) Remove the anchoring from the jack base plate and pull the jacks closer to one another so the chain loosens (see image 12).

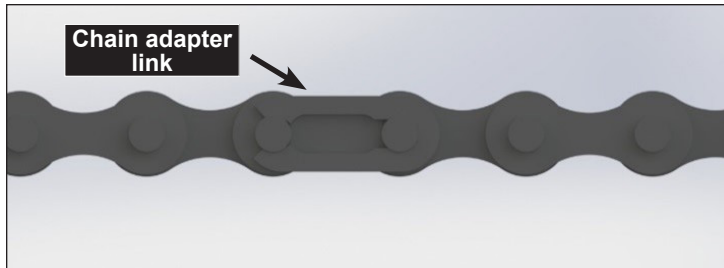
IMAGE 13

- 13) Remove the chain adapter link with the flat blade screwdriver or the long nose pliers on both chains (see image 13).

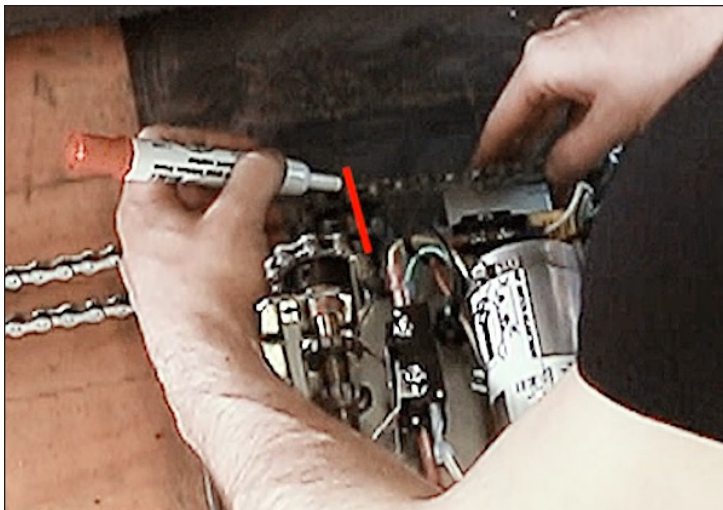
IMAGE 14

To save time, mark the position of the chain on the driving gear, allowing to save the original company adjusted chain tension at reassembly (see image 14).

To save time, mark the position of the chain on the driving gear, allowing to save the original company adjusted chain tension at reassembly (see image 14).

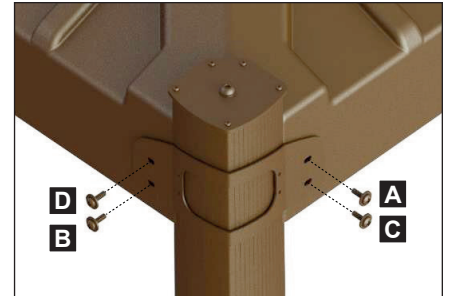
IMAGE 15

- 20) Fasten the corner bracket to the cover **(following the A to D pattern as shown at right)** with four Phillips M6 x 20 mm bolts and 5/16" painted metal washers per post.

- 16) Remove the jack locks, and the ratchet straps.
- 17) Reinstall the sleeves.
- 18) Fasten the corner bracket to the cover (**following the A to D pattern illustrated in image 15**) with four Phillips M6 x 20 mm bolts and 5/16" painted metal washers per post.

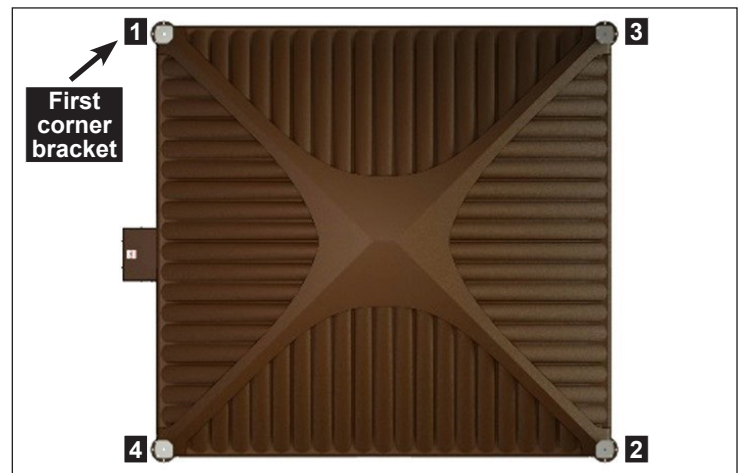
IMAGE 16

- 21) Repeat step 20 for each remaining corner bracket, follow the order of installation (1 to 4) as seen in image 16.

- 19) Repeat step 18 for each remaining corner bracket, follow the order of installation (1 to 4) as seen in image 16.
- 20) Verify the installation of each bracket by sliding the middle sleeve up and down by hand. Make sure it slides without scratching or interfering with the inner or outer sleeve. If all seems to function properly, lower the cover and check if the sleeves are level using a 36" level on both sides of the sleeves.

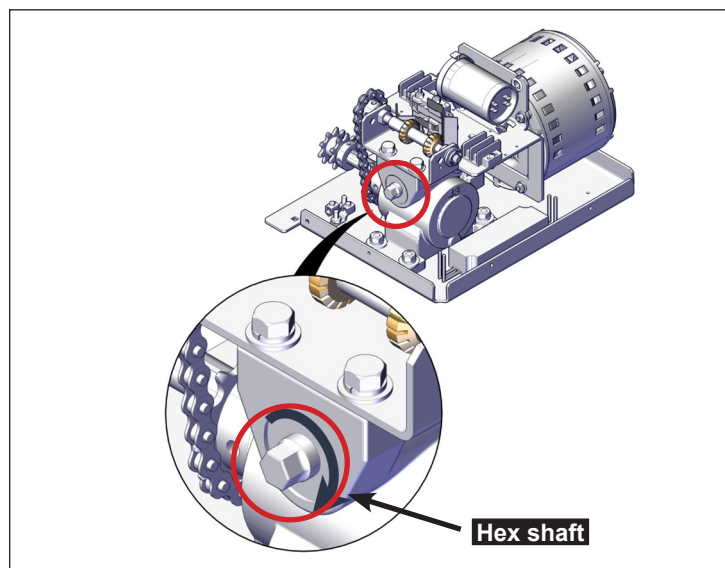
IMAGE 17

- 12) Temporarily reinstall the U-frame on the motor side (insert the bolts without tightening them) to prevent the operator from moving during the next step.
- 13) Make sure the chain is not in contact with the motor jack sprocket on the lower side, and manually lower the cover (turning clockwise) using the hex shaft on the motor until the higher side stops moving and the desired height is reached (which should be aligned with the limit switch). No need to completely remove the chain, but the top of the sprocket needs to be free (see image 17).
