PRODUCT MODELS

- Evolution Cover
- Oasis Cover

This repair procedure should be performed when the replacement of a stopper is required on the Evolution or Oasis spa cover.

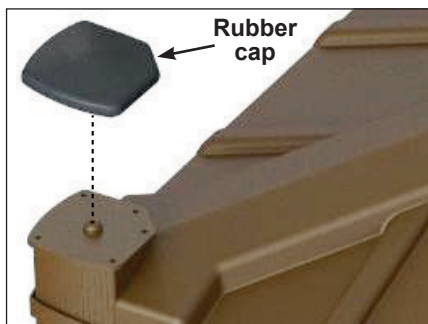
IMAGE 1

- 1) Remove the rubber cap from the post with the defective stopper(s).

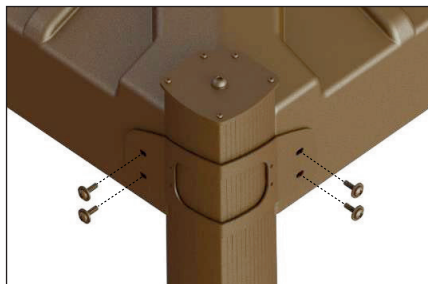
IMAGE 2

- 2) Remove the four M6 x 20 mm bolts and 5/16" painted metal washers from the post to separate it from the cover.

- 7) Fasten the corner bracket to the cover (**following the A to D pattern as illustrated at right**) with four Phillips M6 x 20 mm bolts and 5/16" painted metal washers.

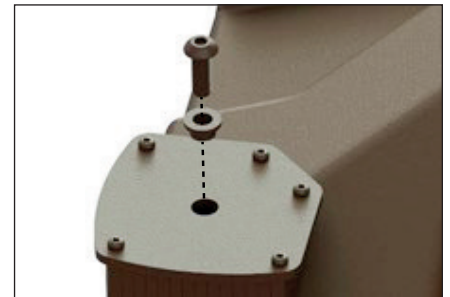
IMAGE 3

- 3) Remove the 3/8-24 x 1" Allen bolt from the post using a 7/32" Allen key. **Do not discard!**

- 4) Carefully fasten the top plate to the post using the five previously removed screws (see image 4).
- 5) Install the 3/8-24 x 1" Allen bolt with the narrow part of the bushing facing downwards using a 7/32" Allen key on the post (see image 3).
- 6) Ensure the cover is still centered using a measuring tape on all four sides. Also, verify whether all the posts are vertically leveled with a 36" level.

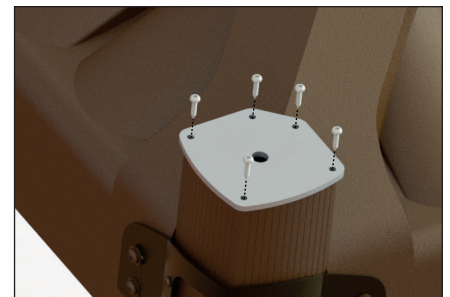
IMAGE 4

- 4) Remove the five no. 8 x 3/4 screws from the post using a Robertson screwdriver to remove the top plate. **Do not discard!**

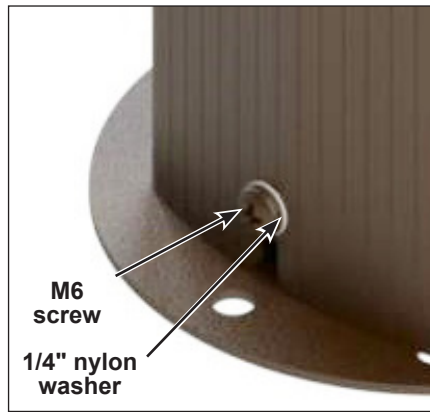
IMAGE 5

- 5) Loosen the Phillips M6 x 20 mm screw at the bottom of the post. **Do not remove the screw.**

- 2) Tighten the Phillips M6 x 20 mm screw at the bottom of the post (see image 5).

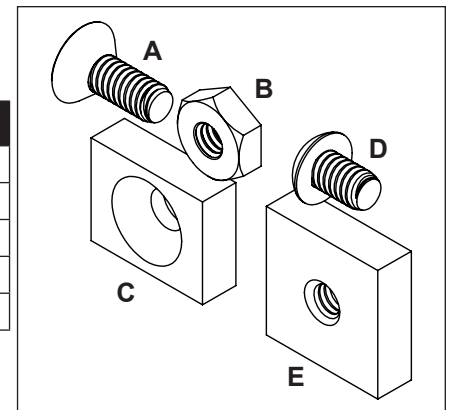
IMAGE 7

The defective stoppers have to be removed in order to separate the three sleeves and install the new stoppers.

Location of the stoppers:

- Inner sleeve: Outside/Bottom
- Middle sleeve: Inside/Top & Outside/Bottom
- Outer sleeve: Inside/Top

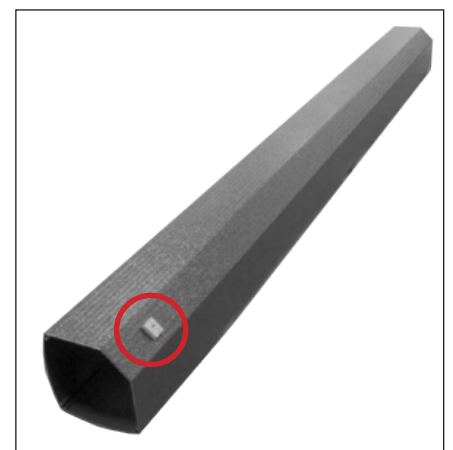
IMAGE 8

- 1) Apply a drop of *Loctite* on the thread of a round head screw (D). Use that screw to secure a threaded stopper (E) in the bottom hole, located on the outside of the inner sleeve, using the 5/8" key and 3/32" Allen key.

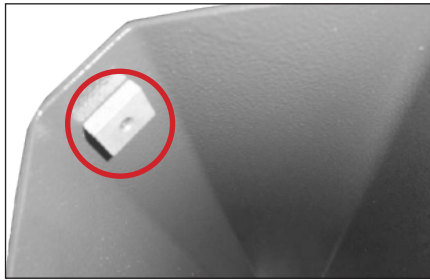
IMAGE 9

- 2) Apply a drop of *Loctite* on the thread of a round head screw (D). Use that screw to secure a threaded stopper (E) in the top hole, located on the inside of the middle sleeve, using the 5/8" key and 3/32" Allen key.

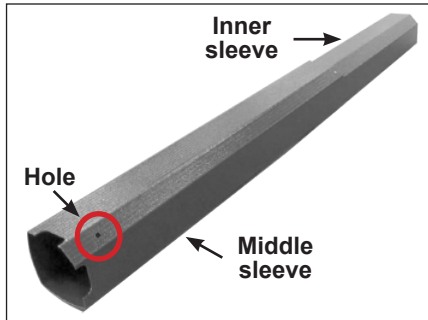
IMAGE 10

- 3) Insert the inner sleeve into the middle sleeve. Make sure the hole at the bottom of the middle sleeve is unobstructed.

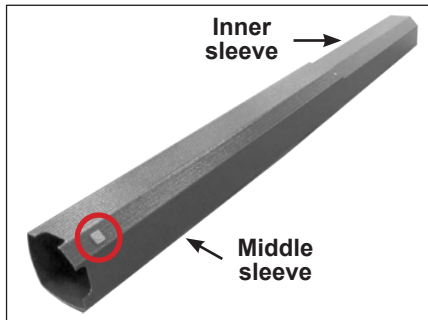
IMAGE 11

- 4) Apply a drop of *Loctite* on the thread of a flat head screw (A). Use that screw and a nut (B) to secure a chamfered stopper (C) in the bottom hole, located on the outside of the middle sleeve, using the 5/8" key and 3/32" Allen key.

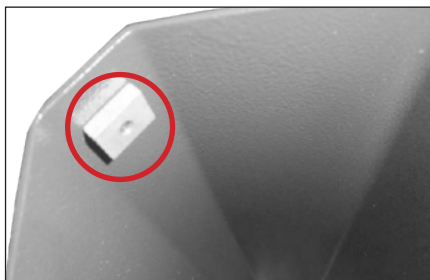
IMAGE 12

- 5) Apply a drop of *Loctite* on the thread of a round head screw (D). Use that screw to secure a threaded stopper (E) in the top hole, located on the inside of the outer sleeve, using the 5/8" key and 3/32" Allen key.

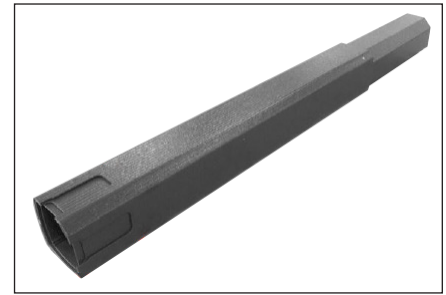
IMAGE 13

- 6) Insert the outer sleeve over the two other sleeves.

- 7) Once the assembly is completed, insert the all-weather seal over the inner sleeve, and slide it all the way down against the outer sleeve.
- 8) Verify the installation of the stoppers by extending the three sleeves by hand. When extending the inner sleeve, the middle sleeve should follow, and then block on the outer sleeve so as not to come out.

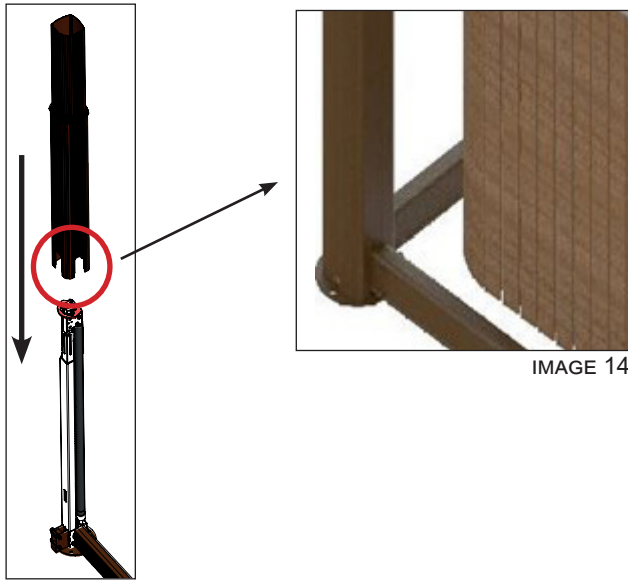
IMAGE 14

- 1) Slide the sleeves over the jack. Be sure to align the opening at the bottom of the sleeves with the U-frame attached (see image 14).

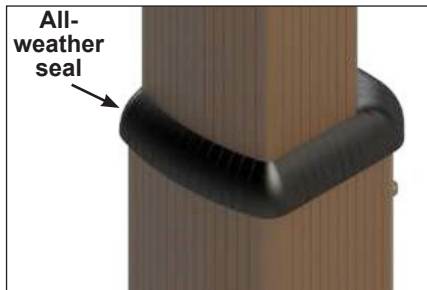
IMAGE 15

- 3) Make sure the all-weather seal on the post is slid all the way down against the outer sleeve.

Failing to properly position this seal may cause serious damage to the post mechanism.

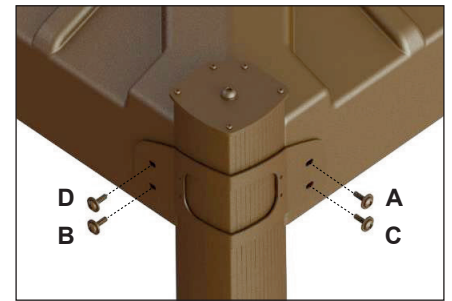
IMAGE 16

Make sure the sleeve is correctly pressed against the outer shell before installing the M6 x 20 mm bolts.

- 8) Verify the installation of the bracket by sliding the middle sleeve up and down by hand. Make sure it slides without scratching or interfering with the inner or outer sleeve. If all seems to function properly, lower the cover and check if the sleeves are level using a 36" level on both sides of the sleeves. If an interference occurs, look at all the parts that have been worked on and make sure there are no broken screws. Reviewing step 2 to retighten the M6 x 20 mm screw could help.
- 9) Install the rubber cap on the post (see image 1).
- 10) Put the key back in its key switch socket. Operate the spa cover normally to see if everything is correct. If there is any issue with the cover, please refer to the troubleshooting section of the Owner's manual or call Covana for the Technical Support department.
