### PRODUCT MODELS

- C-EP Cover with **G2 Posts** only
- Legend Cover with **G2 Posts** only

### PURPOSE OF THE REPAIR PROCEDURE

This repair procedure should be performed if the cable needs to be replaced on the C-EP or Legend spa cover.

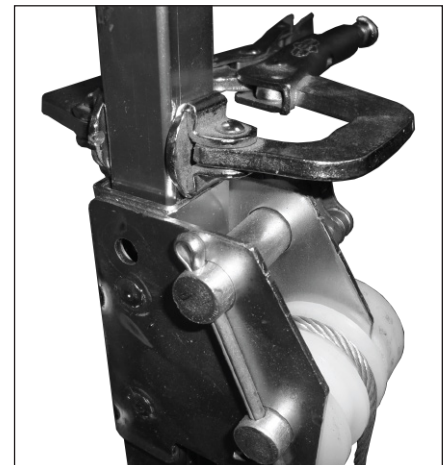
IMAGE 6

- 9) Place locking pliers on the inner tube of the defective jack only, and turn the key switch to lower the jack about 1". This will release the pressure on the cable.

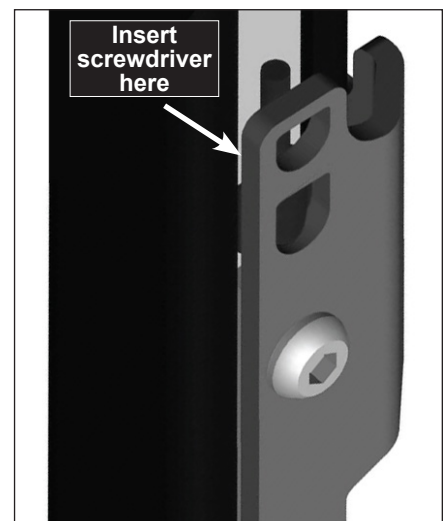
IMAGE 7

- 11) Using a flat blade screwdriver, slightly bend the top of the cable holder outwards (above the bolts) to release the other end of the cable. Discard the defective cable.

- 1) Run the new cable through the pulley and insert it in the cable holder (see image 7). Then, use a hammer and a round tip punch to carefully tap the top of the cable holder back in place.

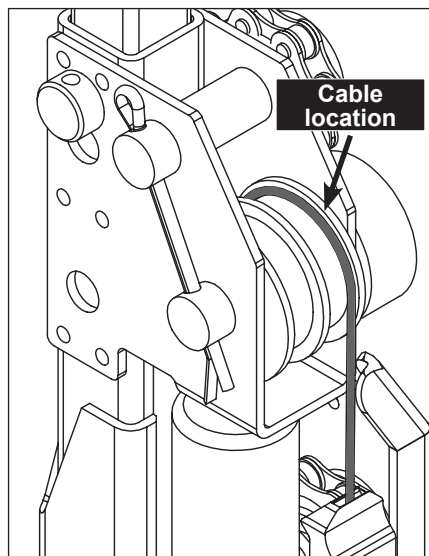
IMAGE 10

- 4) Using the key switch, elevate the cover to apply full pressure to the cable. Make sure that the cable is on the inside part of the pulley, closest to the chain area.

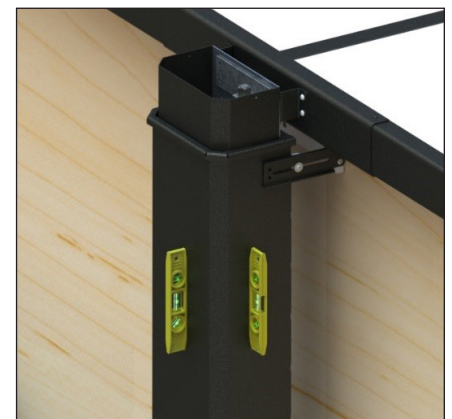
IMAGE 11

- 6) Use a 36" level to make sure the post is still level in both axes. If not, unscrew the mount arms and reposition the sleeve. Use the outer sleeve as a reference.
