PRODUCT MODELS

- Evolution Cover
- Oasis Cover

PURPOSE OF THE REPAIR PROCEDURE

This repair procedure should be performed if the chain tensioner needs to be replaced or adjusted, or if a motor jack has to be replaced on the Evolution or Oasis spa cover.

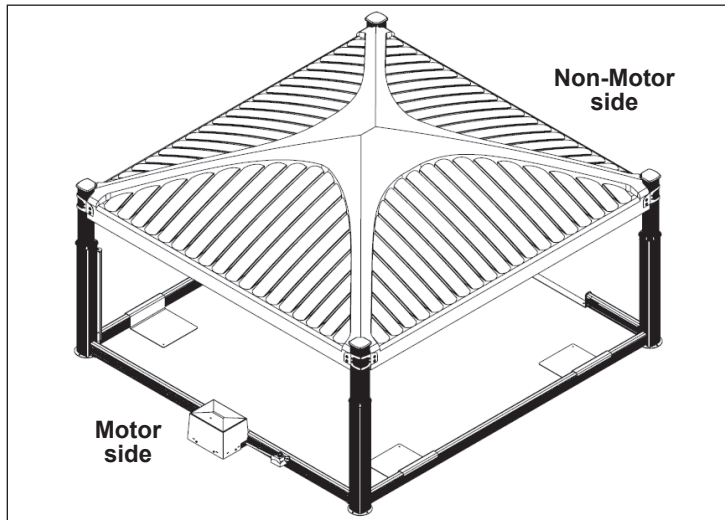
Motor and non-motor sides identification

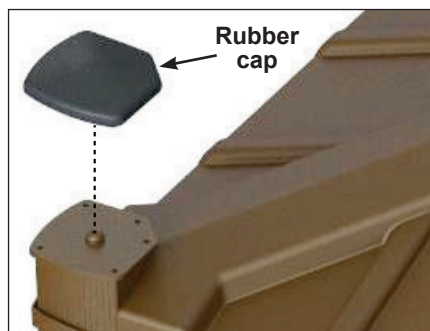
IMAGE 1

- 1) Remove the rubber cap from each post.

18) Install the rubber cap on each post (see image 1).

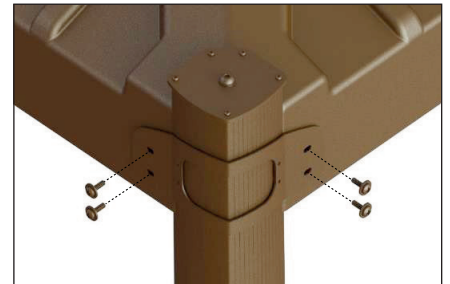
IMAGE 2

- 2) Remove the four M6 x 20 mm bolts and 5/16" painted metal washers from each post to separate the cover from its posts. **Do not discard!** Leave the bracket attached to the sleeve.

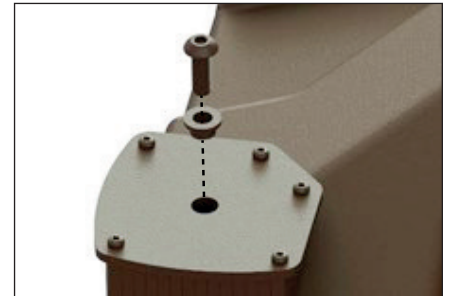
IMAGE 3

- 3) Remove the 3/8-24 x 1" Allen bolt with a 7/32" Allen key from each post. **Do not discard!**

14) Install the 3/8-24 x 1" Allen bolt with the narrow part of the bushing facing downwards using a 7/32" Allen key on each post (see image 3).

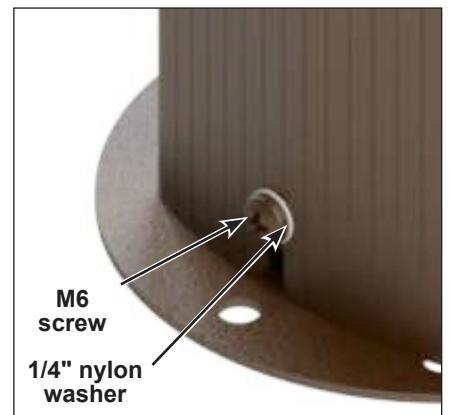
IMAGE 4

- 4) Loosen the Phillips M6 x 20 mm screw at the bottom of each post. **Do not remove the screw.**

12) Tighten the Phillips M6 x 20 mm screw at the bottom of the post (see image 4).

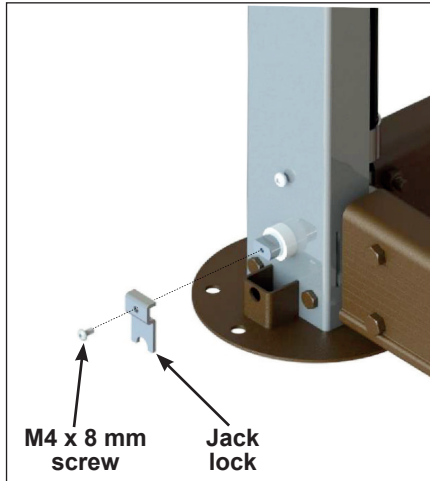
IMAGE 5

- Slide the sleeves upward to expose the jack. Set them aside in a safe location. If both motor jacks need to be replaced, identify their sleeves to ensure they will not be swapped.

If the cover is from **March 2019 or earlier**, unscrew the Phillips M4 x 8 mm screw to remove the jack lock at the bottom of each jack. **Keep the locks and the hardware for future use** (see image 5).

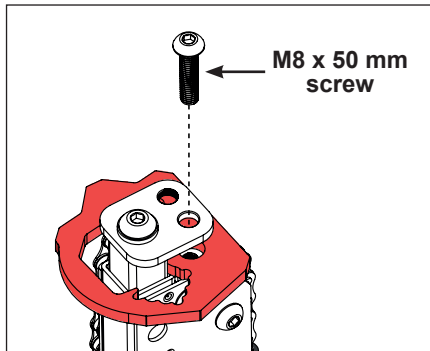
IMAGE 6

- If the cover is from **March 2019 or earlier**: For each post, put the jack lock back in its original place and install the M4 x 8 mm screw to secure it. Turn the shaft with the key to align it with the bracket if need be.

If the cover is from **April 2019 and up**, remove the M8 x 50 mm screw at the top to unlock each jack assembly (see image 6).

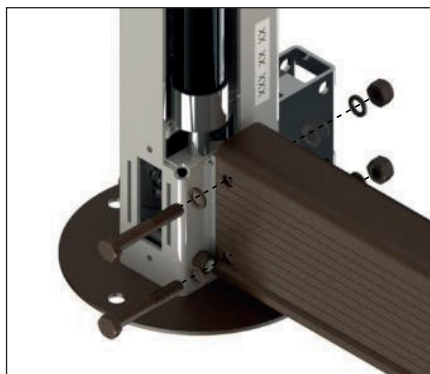
IMAGE 7

- Detach the long U-frames from the drive shaft by removing both hexagonal 5/16-18 x 2" bolts from each post using a 1/2" socket wrench and spanner.

9) Install the 5/16" hexagonal screws at the ends of each U-frame (see image 7).

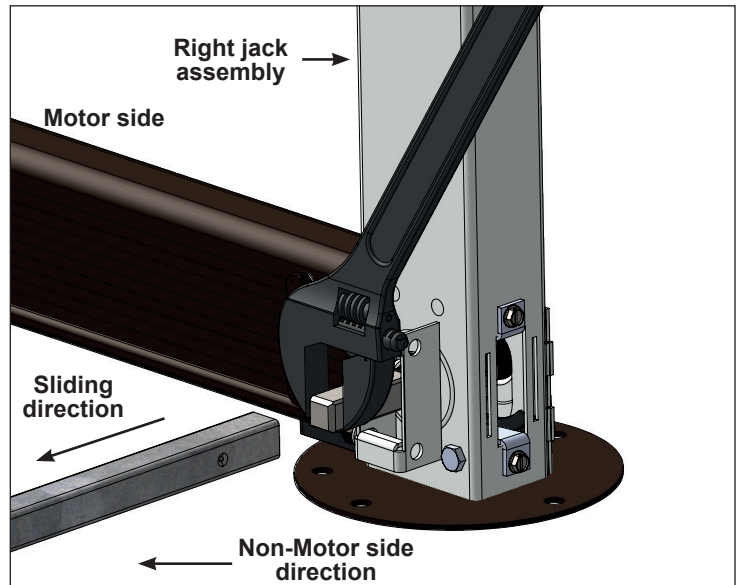
IMAGE 8

- Lift the U-frames and set them aside.
- Pull the motor jack away from the motor side so the drive shaft disengages from one side (see image 8).

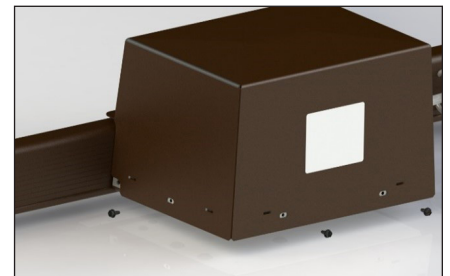
IMAGE 9

- Remove the four screws holding the operator cover in place. Lift the cover and set it aside.

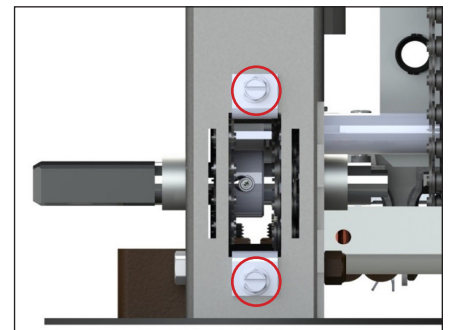
IMAGE 10

- Remove the screws holding the chain guide in place. Then, remove both chain guides from each jack.

- 4) Reinstall the chain guides (see image 10).
- 5) Gently position the U-frame on the chain making sure the chain tensioners are correctly positioned to be able to put the screws back in.

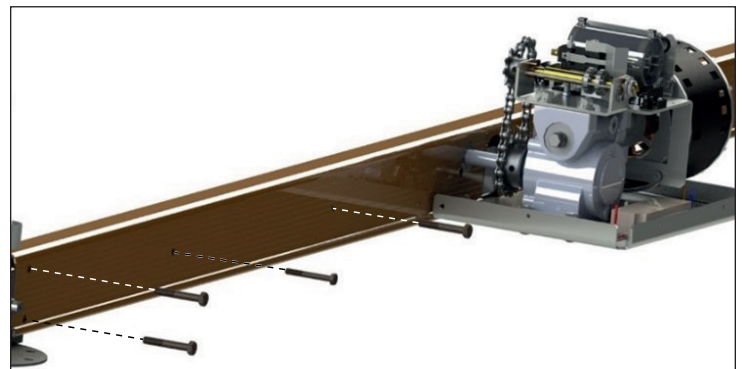
IMAGE 11

- Remove all the hexagonal screws on the motor side U-frame. Gently lift the U-frame and set it aside (see image 11).

- 6) Put all the screws in the U-frame, the 5/16" at the end, and the 1/4" for all the chain tensioners (see image 11).
- 7) Reinstall the drive shafts on both motor jacks and reinstall the U-frame over it. Make sure the drive shaft is correctly engaged on the jacks as you position the U-frame over it (see image 16).

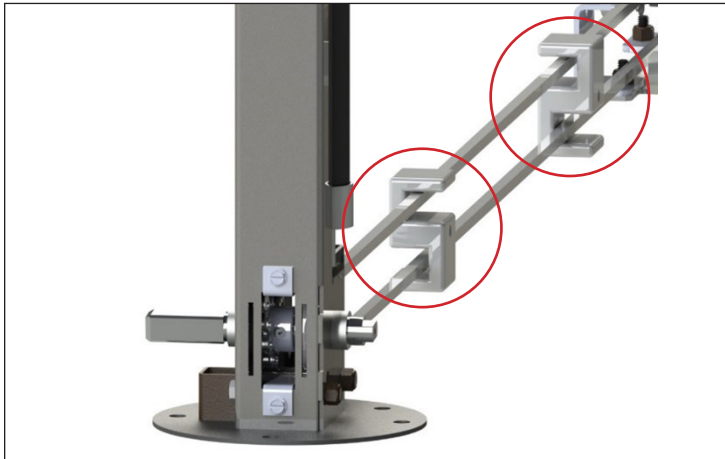
IMAGE 12

13) Remove the chain tensioners from the chain (see image 12).

- 2) Pull the jacks away from one another so the chain is tensioned. You may have to adjust the chain, to make the tension even on both chains.
- 3) Install the chain tensioners on the chains and use the U-frame to align them with the holes (see image 12).

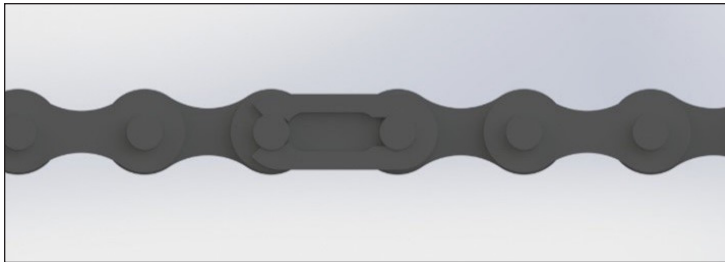
IMAGE 13

15) Remove the chain adapter link with the flat blade screwdriver or the long nose pliers on both chains (see image 13).

- 1) Install the chains and the chain adapter links in the new jack(s), one side at a time. Ensure they are relatively tight on each side (see image 13).

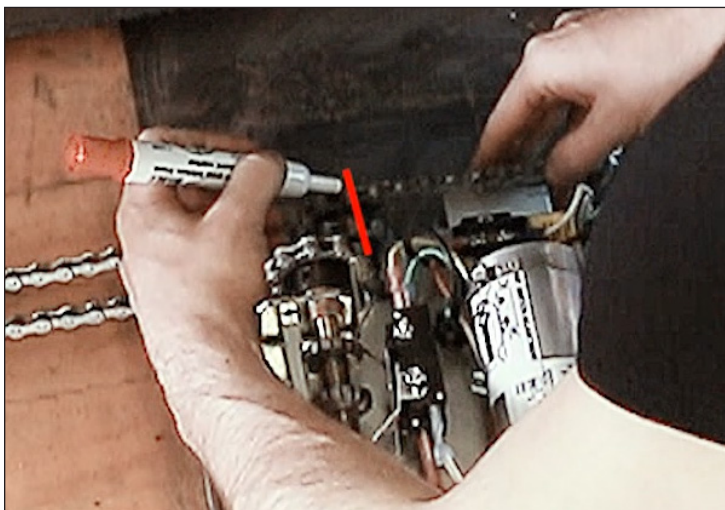
IMAGE 14

To save time, mark the position of the chain on the driving gear, allowing to save the original company adjusted chain tension at reassembly (see image 14).

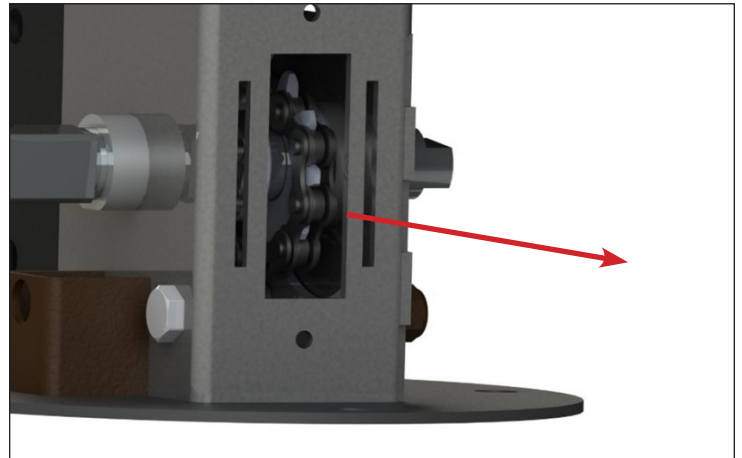
IMAGE 15

16) Lift the top and bottom part of the chain to pull it away from the jacks (see image 15).

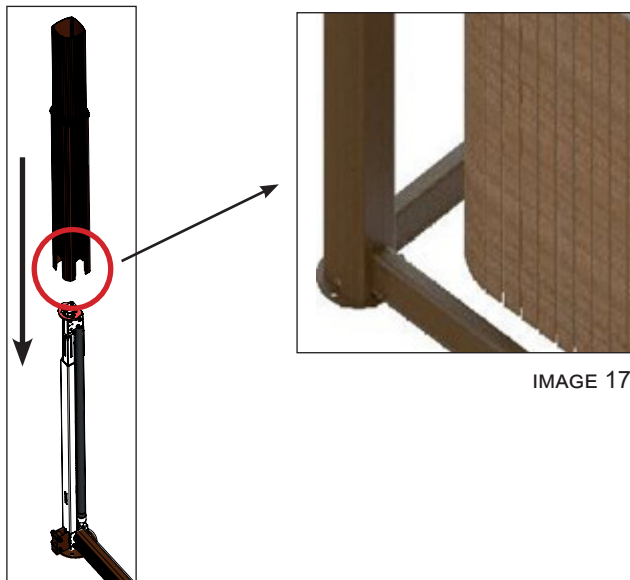
IMAGE 17

11) Slide the sleeves over the jacks. Be sure to align the opening at the bottom of the sleeve with the U-frame (see image 17). Ensure not to swap the sleeves.

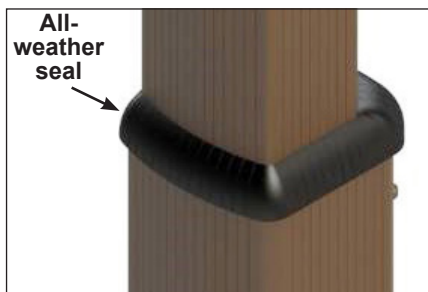
IMAGE 18

13) Make sure the all-weather seal on the post is slid all the way down against the outer sleeve.

Failing to properly position this seal may cause serious damage to the post mechanism.

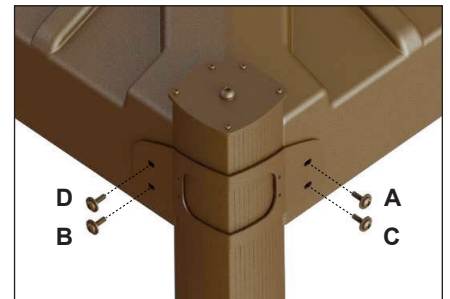
IMAGE 19

16) Fasten the corner brackets to the cover (according to the order of installation in image 20, and following the A to D pattern in image 19) with four Phillips M6 x 20 mm bolts and 5/16" painted metal washers per post.
