PRODUCT MODELS

- Evolution Cover with **G3 Posts** only
- Oasis Cover with **G3 Posts** only

PURPOSE OF THE REPAIR PROCEDURE

This repair procedure should be performed if a red alignment bracket needs to be replaced on the Evolution or Oasis spa cover.

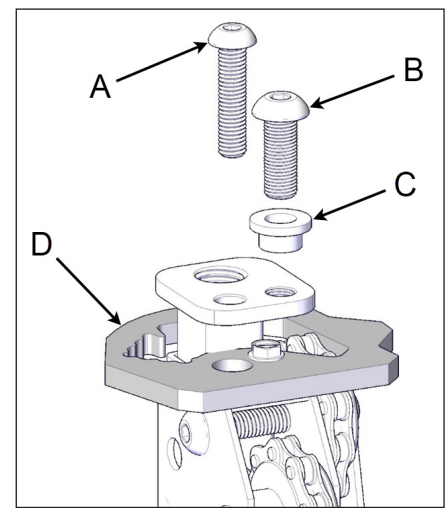
IMAGE 1

If the alignment bracket (D in image 1) has been removed by mistake (e.g., while unpacking the cover from the crate), continue the installation without the bracket **until it is time to remove the jack lock screws, right before sliding the sleeves over all four jacks**. Then, follow the instructions below.

- 1) Once all the drive shafts are installed, the jack lock screws located at the top of the non-motor-side jacks can safely be removed. Remove the M8 x 50 mm jack lock screws (A in image 1) and keep them for future use.
- 2) Unscrew the 3/8" x 1" socket screw (B in image 1) with a 7/32" Allen key on the top of all four jack assemblies. Set the screws and bushings (C in image 1) aside.

ID	DESCRIPTION
A	M8 x 50 mm Jack lock screw
B	3/8" x 1" Socket screw
C	Bushing
D	Alignment bracket (Red)

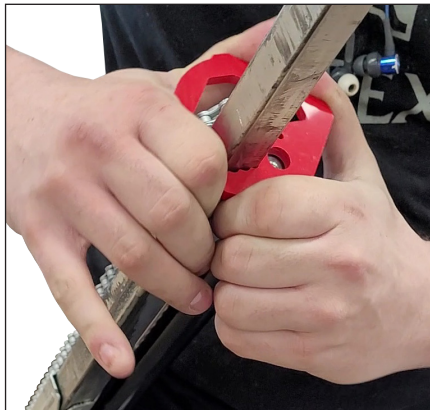
IMAGE 3

- 5) Slide the alignment bracket over the jack.

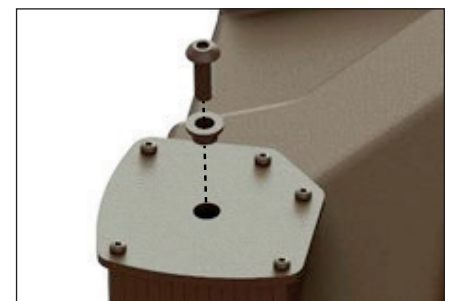
IMAGE 7

- 2) Remove the rubber cap from the defective post only.

- 3) Remove the 3/8-24 x 1" Allen bolt with a 7/32" Allen key from the defective post only.
Do not discard!

- 13) Using a Robertson screwdriver, fasten the top plate to the post using the five previously removed screws (see image 8).
- 14) Reinstall the 3/8-24 x 1" Allen bolt with the narrow part of the bushing facing downwards using a 7/32" Allen key on the post (see image 7).
- 15) Install the rubber cap on the post (see image 6).
- 16) Put the key back in its key switch socket. Operate the spa cover normally to see if everything is correct. If there is any issue with the cover, please refer to the troubleshooting section of the Owner's manual or call Covana for the Technical Support department.

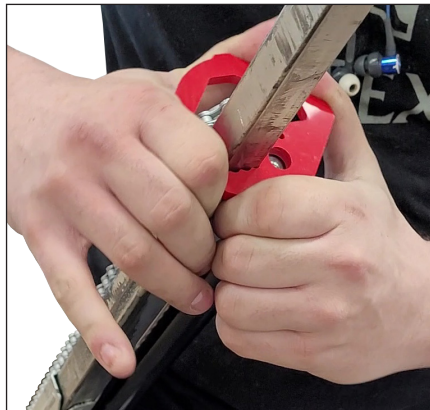
IMAGE 10

- 7) Slide the alignment bracket over the jack.

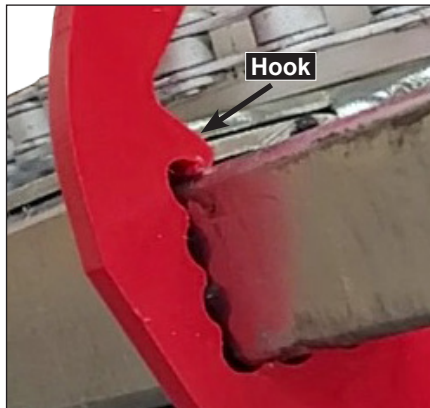
IMAGE 11

- 8) Slightly squeeze and rotate the alignment bracket so that it snaps onto the top of the jack.

- 9) The hook of the alignment bracket must lock in place on the driving shaft.
