PRODUCT MODELS (North America & Europe)

- Evolution cover
- Oasis Cover

This procedure describes how to test the power and resistance of the key switch.

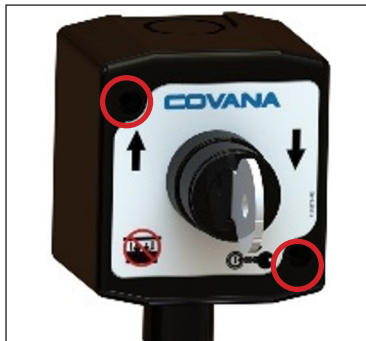
IMAGE 1

- 1) Remove the cover of the key switch by unscrewing both screws using a Phillips screwdriver.

- 8) Repeat step 7 with the screws from the other contact block (see image 2, **C** and **D**).
- 9) Fasten the cover of the key switch with both Phillips screws making sure not to pinch the wires underneath.
- 10) Reinstall the rubber cap on the key switch.
