PRODUCT MODELS (North America & Europe)

- Evolution cover
- Oasis Cover

PURPOSE OF THE REPAIR PROCEDURE

This repair procedure should be performed if the capacitor needs to be replaced on the Evolution or Oasis spa cover.

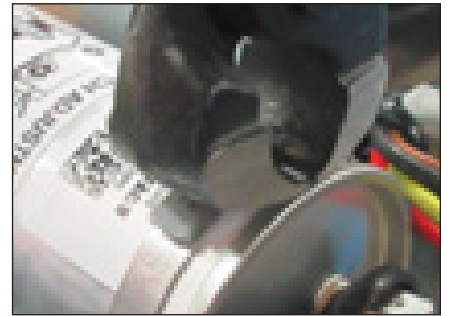
IMAGE 9

- 5) Using ear clamp pliers, grab the indents of both sides of the ear, then squeeze the tool. Pinch as tight as possible without damaging the clamp. Repeat for the other pinch clamp.
