PRODUCT MODELS*

- C-EP Cover
 - Legend Cover
- *Specifically, the chains of the G3 generation jack (with a hole on the side of the jack).

PURPOSE OF THE REPAIR PROCEDURE

This repair procedure should be performed if the cover is “bouncing”.

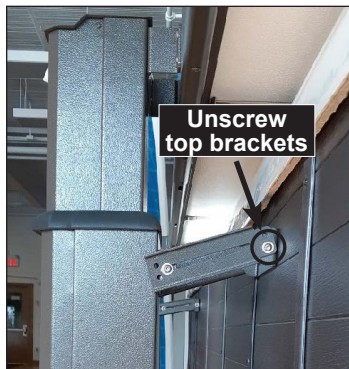
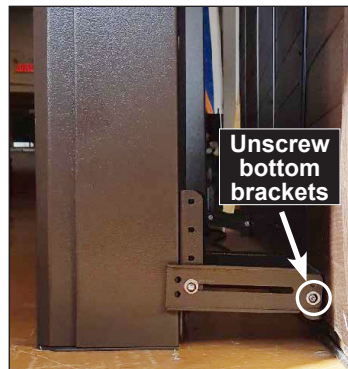
- 1) Raise the cover to its highest position.
- 2) Unscrew the top and bottom brackets of one of the posts with a 5/32" Allen key and a 7/16" Allen key (see images 1-A and 1-B).

- 12) Reinstall and secure the top and bottom brackets of the post.
- 13) Operate the cover up and down twice, and put it back to its highest position.
- 14) Steps 2 to 13 MUST be repeated for the three other posts, one post at a time.
- 15) Put the key back in its key switch socket. Operate the spa cover normally to see if everything is correct. The previous steps should have resolved the bouncing issue of the cover. If the bouncing problem persists, call Covana for the Technical Support department.

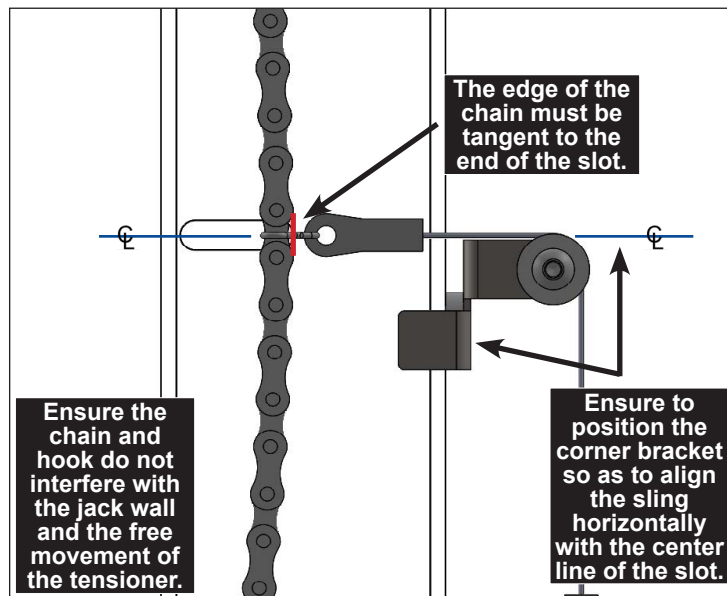
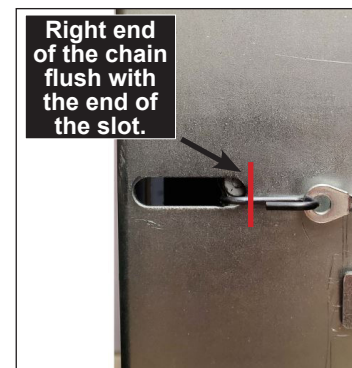
- 7) When the hook is attached to the chain, and the mass is free to go down, the right side of the chain must be aligned with the right side of the slot. Therefore, both edges must be tangent to each other (see red line in images 5-A and 5-C). If this alignment is not possible, the chain will need to be adjusted; see next steps.

- 8) If the edge of the chain and the slot were not tangent in step 7, use a 3/16" Allen key to screw/unscrew the adjustment screw until the chain is tangent to the right side of the slot. The hook might touch the side wall of the post and interfere with its movements. To solve this issue, pull the mass up and down a few times until the whole system is in place.
