Cable replacement Procedure

Greasing Instruction Procedure

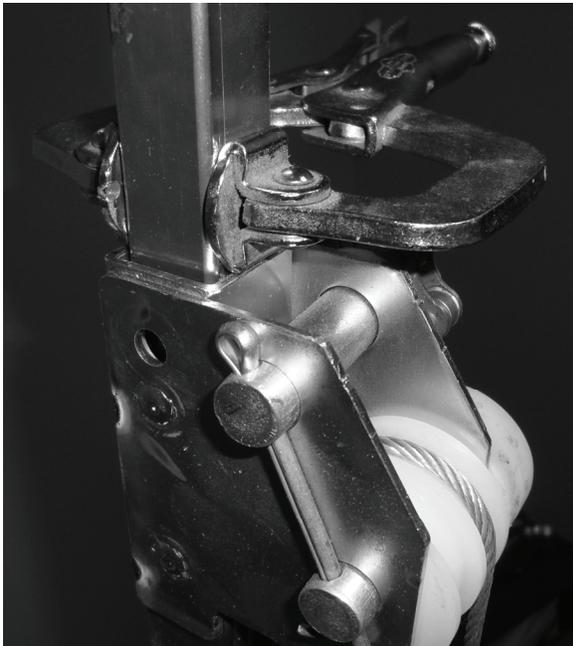
7. While performing the greasing instruction and the system is extended the cable will be will exposed on the post and allow it to be easily replaced.
8. Place locking pliers as shown and turn the key to lower the system and this will release the pressure on the cable. Lower about an inch.

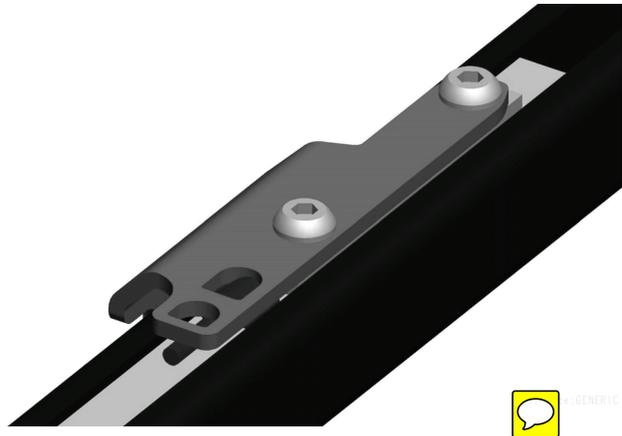
9. Loosen the bolts on the cable clamp (see image #2) and this will release the cable.
10. Insert the cable hook (see image #3) and pull up on the cable to seat the hook (see image #4). It is a good idea to wrap some electrical tape or heat shrink around the cable and the cable hook.

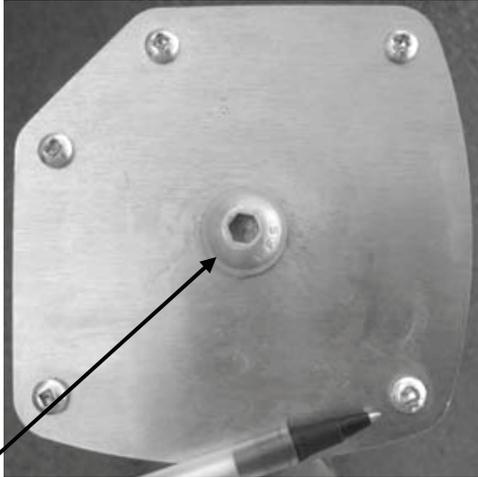
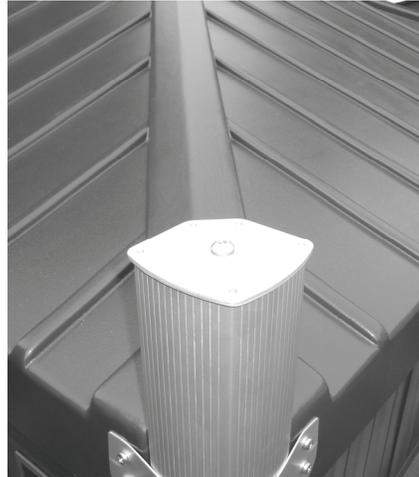
Top Bolt

1. Ensure the cover is lowered completely and resting on the tub
 2. Remove the five screws from each of the remaining posts
-

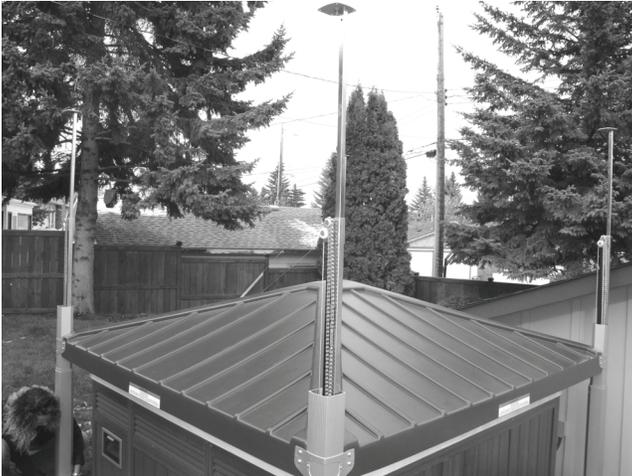
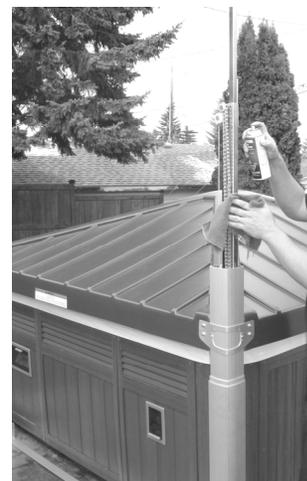
1. Extend the posts to their full height
2. Using a spray lubricant - WD-40 or 3in1 oil - lubricate all the mechanical components that are visible, especially the vertical tubes. Do not use grease in cold climates.
3. Retract the posts and carefully reinstall the screws by hand, screws could break if a power tool is used
